National Transportation Safety Board Aviation Accident Factual Report

Location:	Kake, Alaska	Accident Number:	ANC19FA012
Date & Time:	January 29, 2019, 18:11 Local	Registration:	N13LY
Aircraft:	Beech 200	Aircraft Damage:	Destroyed
Defining Event:	Loss of control in flight	Injuries:	3 Fatal
Flight Conducted Under:

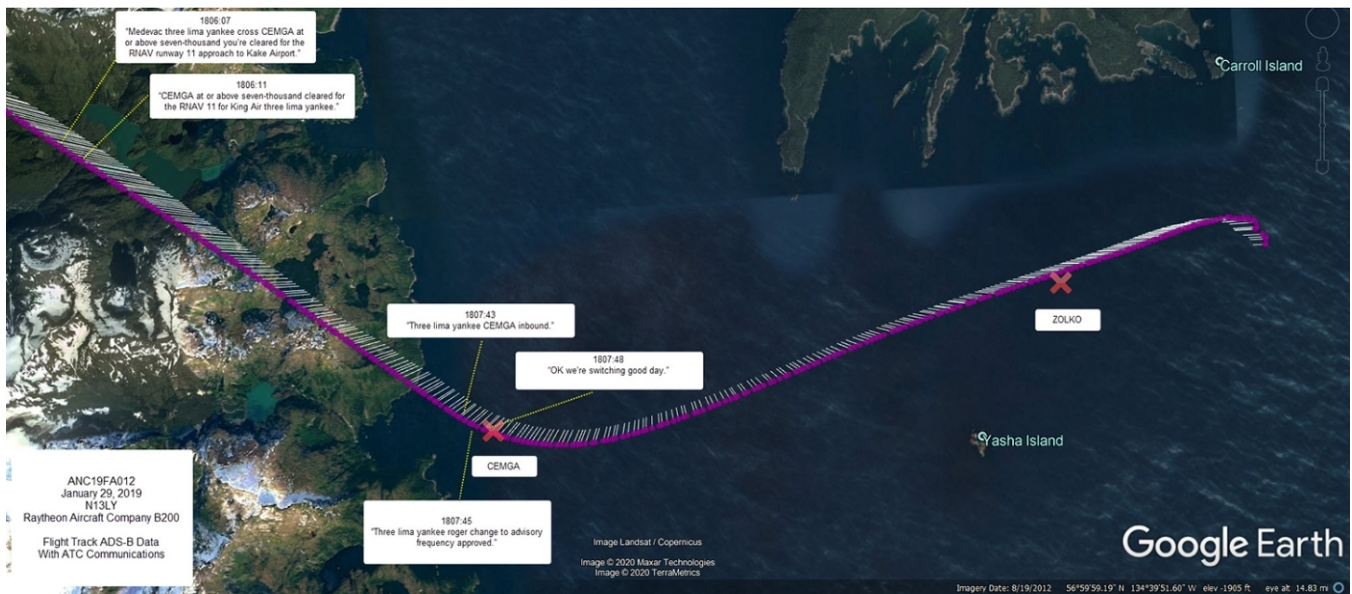
A review of archived FAA radar and ADS-B data revealed that the accident airplane crossed the CEMGA waypoint on the RNAV runway 11 approach at an altitude of about 7,000 ft above mean sea level (msl), then turned northeast and crossed the ZOLKO initial approach fix about 5,000 ft msl. The airplane then initiated a gradual descent and continued northeast toward the JOJOE intermediate fix. About 1810, while the flight was between ZOLKO and JOJOE, the airplane entered a right turn toward a southerly heading and began a rapid descent, losing about 2,575 ft of altitude in 14 seconds. The last radar data point was at 1810:36 when the airplane was at 1,300 ft msl and heading 143° with a ground speed of 174 knots. (See figure 1 and figure 2.)

Figure 1 - ADS-B track of the accident airplane with air traffic communications for the approach clearance.

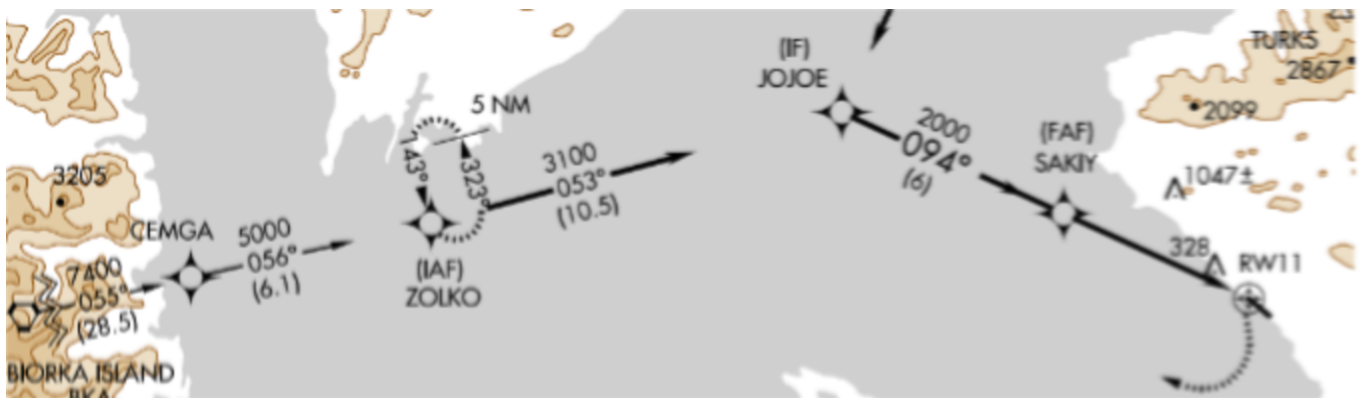
Figure 2 - Excerpt RNAV (GPS) RWY 11 Approach PAFE.

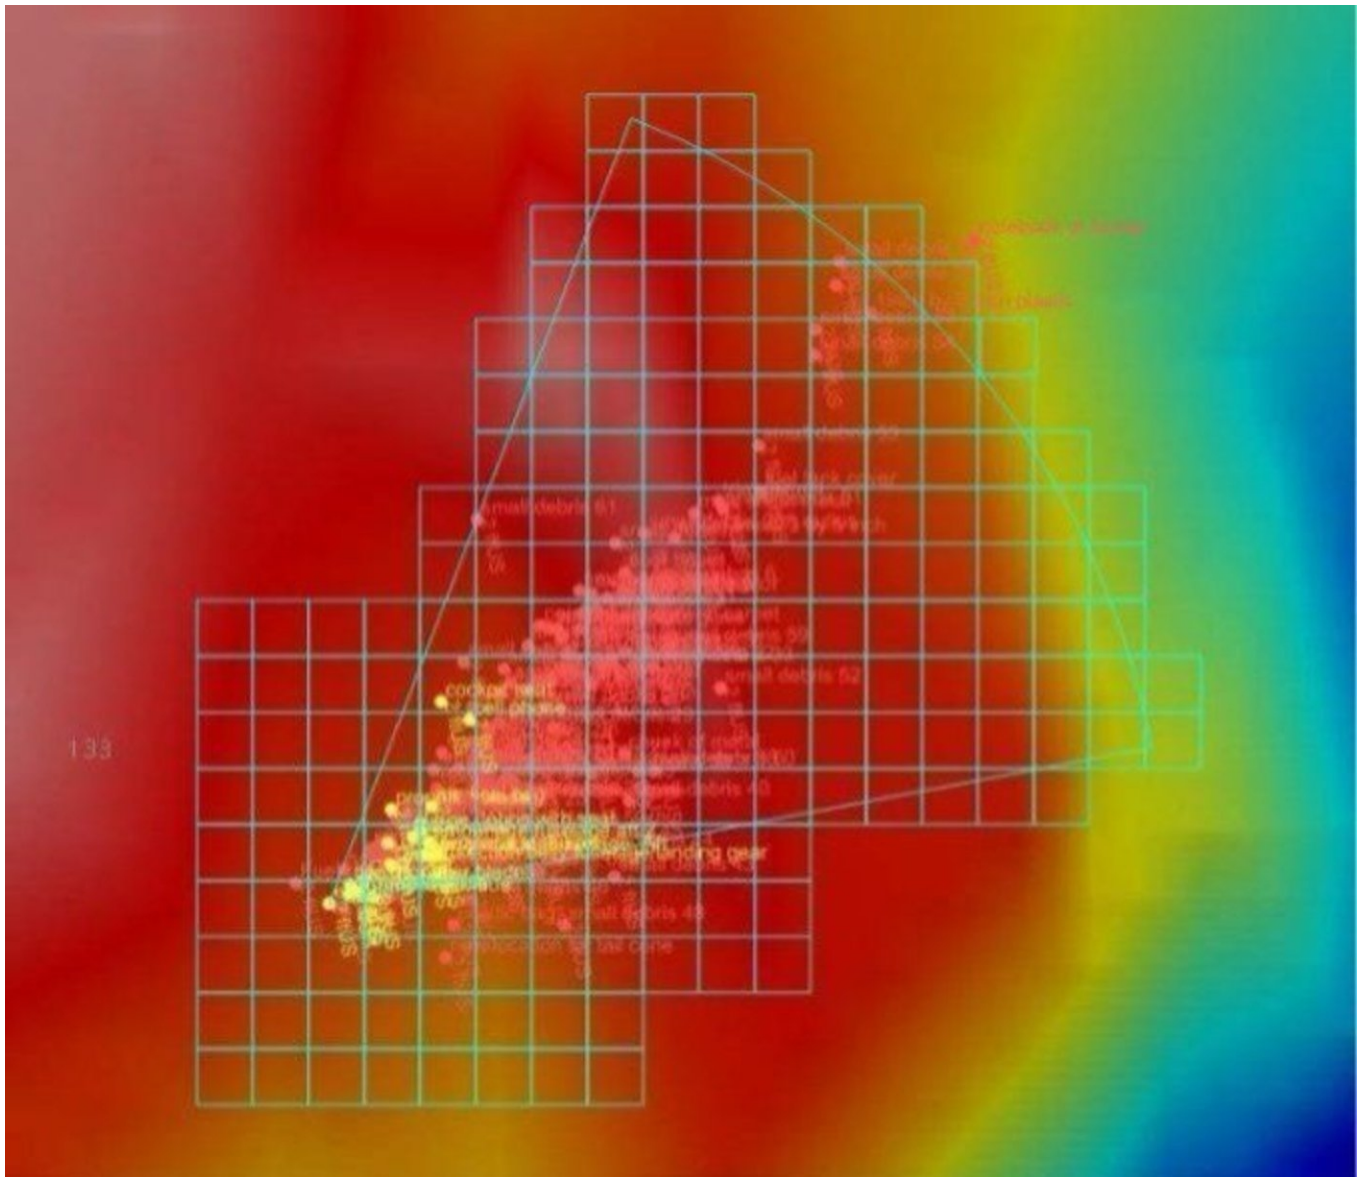
The airplane impacted the ocean waters of Frederick Sound and was located with the assistance of a remote operated vehicle (ROV) on March 19, 2019, at a depth of about 500 ft. A cone shape debris field spanned about 1,650 ft on a bearing of 45°, with the lighter debris farther northeast due to the ocean current. (see figure 3.)

Figure 3 - Debris field figure produced by TerraSond courtesy of Alaska Claims Services, Inc.
