U.S. Department of
Homeland Security
United States
Coast Guard

FINAL ACTION OF MAJOR INCIDENT INVESTIGATION REPORT INTO THE CIRCUMSTANCES SURROUNDING THE CRASH OF AIRSTA SITKA MH-6016

Subj: MAJOR INCIDENT INVESTIGATION (MII) INTO THE CIRCUMSTANCES
SURROUNDING THE CRASH OF AIRSTA SITKA MH-6016 ON 13NOV23

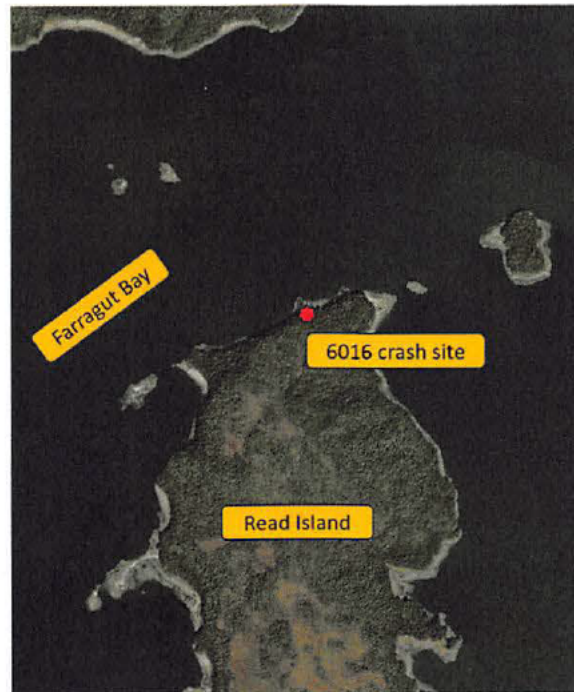
Exhibit 7 - Figure 5

(7) CG6016 arrived in the vicinity of LM at approximately 22:18. LM was anchored approximately 200 yards north of Read Island. The island was forested with trees in the immediate area that reached up to 140 feet AGL. (Exhibits 2, 7-Figures 5-7, 9)

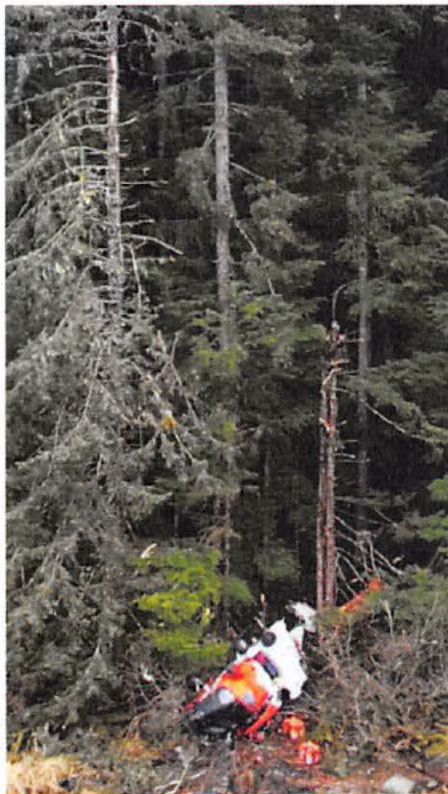
Exhibit 7 – Figure 9

(72) Following the crash multiple trees in the vicinity of CG6016 showed evidence of recent damage. (Exhibit 7-Figures 7, 9, 10, 12)

(73) One tree, approximately 20 feet north of where CG6016 came to rest, showed evidence of fresh damage to the trunk from approximately 65 to 75 feet AGL. (Exhibit 7-Figures 7,9)
